# BURST PRESSURE FAILURE OF TITANIUM TANKS DAMAGED BY SECONDARY PLUMES FROM HYPERVELOCITY IMPACTS ON ALUMINUM SHIELDS

H. Nahra<sup>1</sup>, L. Ghosn<sup>1</sup>, E. Christiansen<sup>2</sup>, B.A. Davis<sup>2</sup>,  
C. Keddy<sup>3</sup>, K. Rodriguez<sup>3</sup>, J. Miller<sup>4</sup> and W. Bohl<sup>4</sup>

<sup>1</sup>NASA- Glenn Research Center, 21000 Brookpark Rd., Cleveland, OH 44135

*American Physical Society  
Shock Compression of Condensed Matter  
June 26-July 1, 2011  
Chicago, IL*

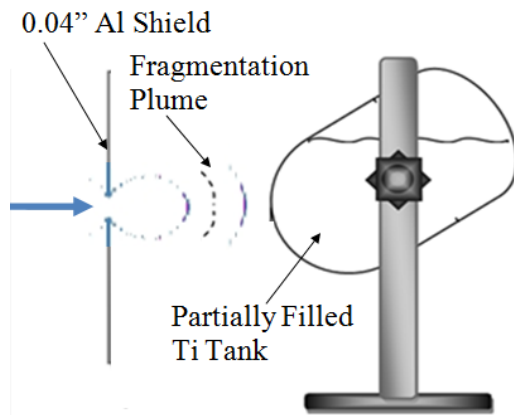
**Figure 1.** Schematic of the hypervelocity impact on the titanium tanks partially filled with water.

The two HVI tests reported here have been performed at NASA White Sands Testing Facility (WSTF). Each test consisted of launching a particle at about 7 km/s at an aluminum shield behind which an unpressurized titanium tank partially filled with water was fixed in an orientation normal with respect to the ejected secondary plume from the first penetration through the aluminum shield. Figure 1 shows a basic schematic of the HVI tests. The projectiles for the two HVI tests were 1.6 mm Aluminum and 3.6 mm Nylon at ~7 km/s. A scan of the tank thickness was performed on the two tanks before impact for proper tank orientation and post testing surface characterization. The thickness ranged from 0.04" to 0.1" from the welding joint to the boss. The goal was to achieve depths of penetration ranging from 10 to about 40% for the two impacting projectiles.

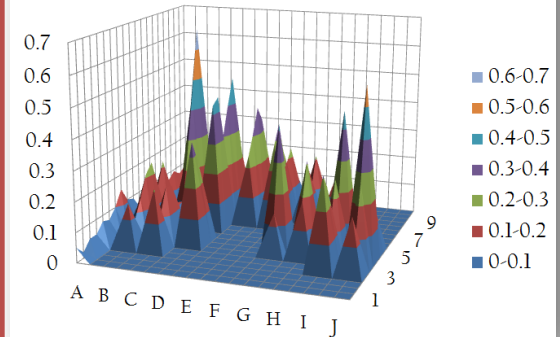
0062 Tank

- Damage Distribution of Tank 0062 caused by 1.6 mm Al projectile and Sabot pieces
  - Exhibits two areas of damage which may have been caused by the sabot piece impacting the Al shield
  - Distribution exhibited deeper than expected impacts
- Damage Distribution of Tank 0092 caused by 3.6 mm Nylon projectile
  - Exhibited Uniform damage distribution as seen in stressed and unstressed coupon HVI tests

Depth Distribution of Measured Craters

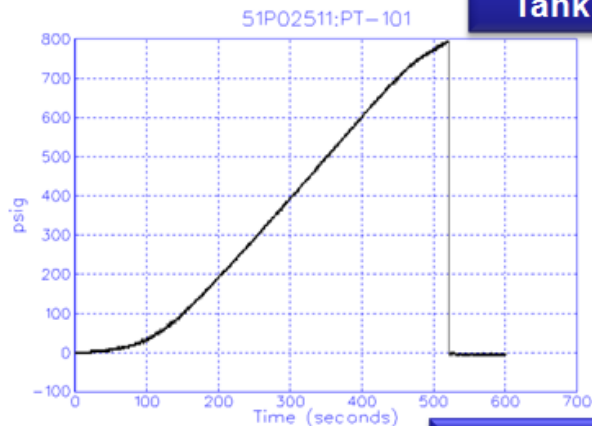
**Tank 251 Baseline**

The strain versus time history of tank #0251 during pressurization and up to the failure is shown in Fig. 4, while Fig. 5 shows the same data

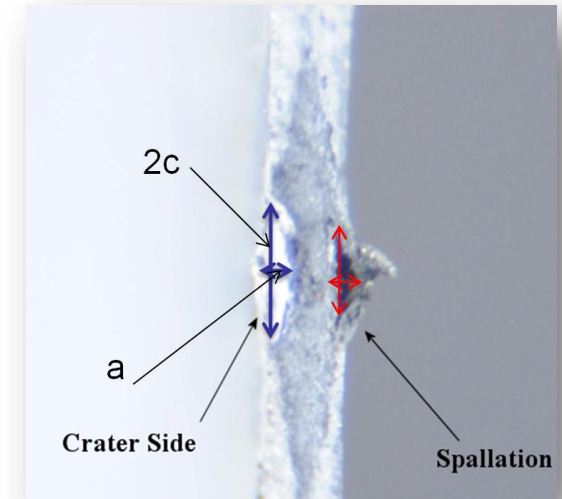
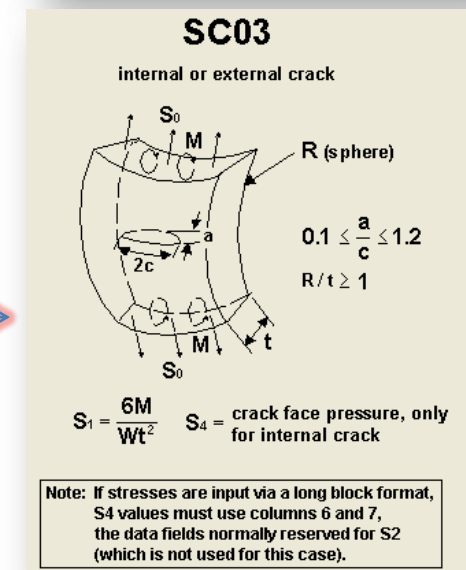
A linear fracture mechanics analysis was performed on a spall crack that was detected in the process of examination of the crack line of tank

#0062 and that resulted from a secondary plume particle impact. The code NASGRO version 6.1 with routine SC03 for external and internal cracks was used to perform this analysis. The formulation is based on the work of Newman and Raju, [2,3]. The option of internal crack was exercised in this calculation. The spall crack characteristics were measured from a higher magnification photograph obtained from the crack line. The crack depth was 0.0082" and crack length 0.05".

- Determination of the failure mode of the tank under burst pressure
  - Failure caused by loss of strength
  - Failure cause by dynamic crack propagation
- Perform a fracture analysis and compare toughness of Titanium with the predicted stress intensity factors
  - On the inside surface where a spall has been observed
    - $a = 0.0082''$ ,  $2c = 0.05''$ ,
    - $c = 0.025''$
    - $a/c = 0.33$
  - Used NASGRO to compute the stress intensity factor and compared with the Titanium toughness

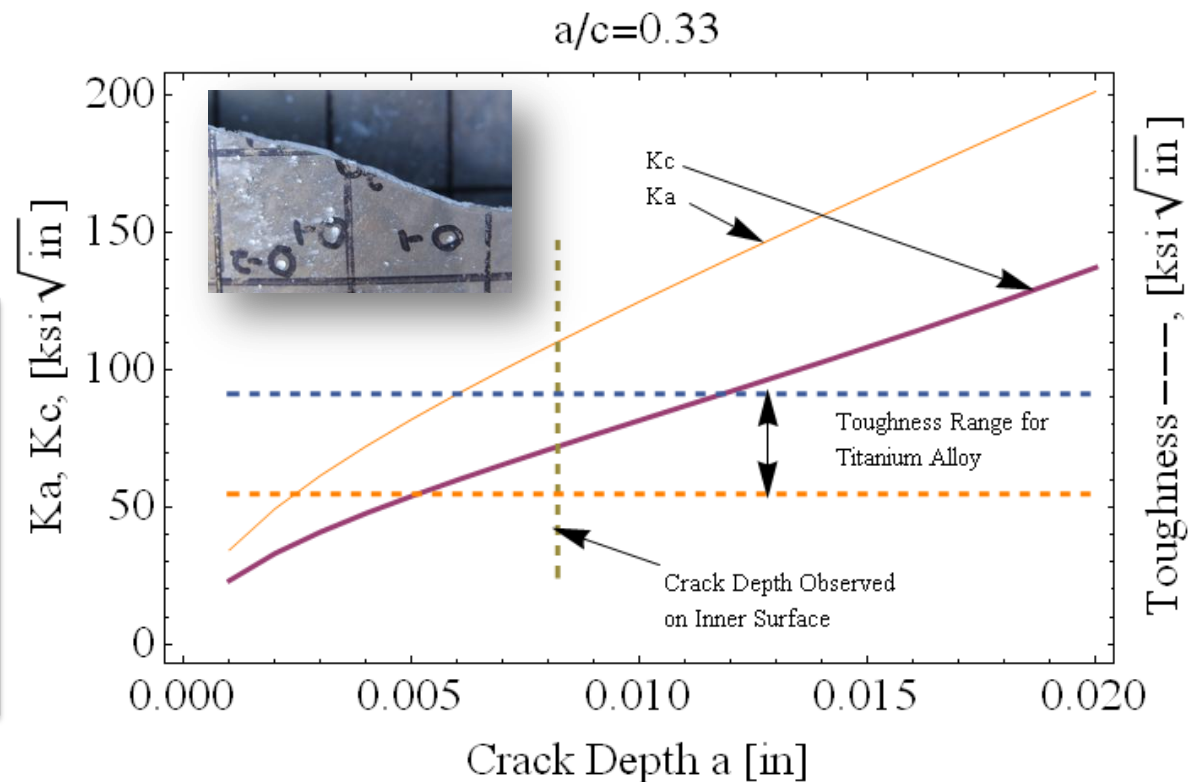
Need to look at the area of crack to see any traces of crack propagation and propagation speed

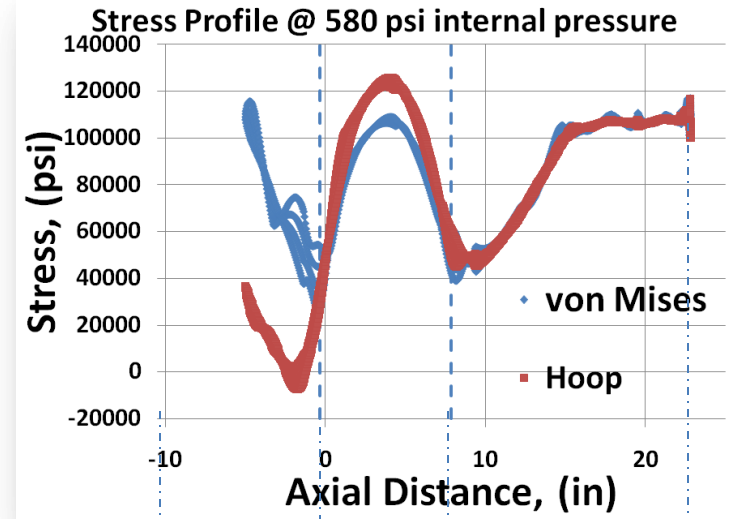
# Tank Preliminary Finite Element Analysis

To further corroborate the argument, a finite element analysis (FEA) on the tank was performed. For a pressure of 580 psi, the FEA showed in Fig. 7 that the Von-Mises stresses/criterion was below the yield limit of Ti-6Al-4V, yet the calculated stresses from the shell theory showed yield and ultimate strength exceedance at the higher burst pressures of tanks #0092 and #0125.

- A plastic-elastic axi-symmetric finite element analysis was performed on the tank with a x-y coordinates provided from the thickness profile
- Pressure in tank assumed at 580 psi
- Yield strength at 125 ksi
- Ultimate strength at 145 ksi

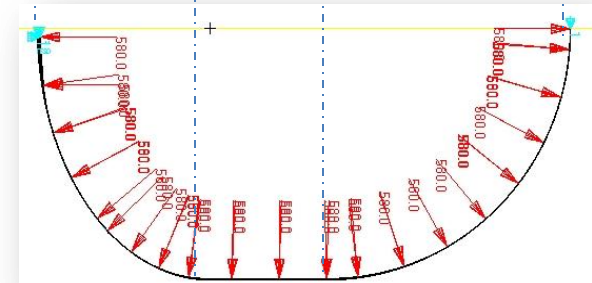
Axial Direction

- Results show that at 580 psi, the hoop and Von Mises stresses are below the ultimate the yield strength of Ti 6Al4V
- This corroborates the findings that failure at 580 psi was caused by a crack propagation and was not driven by strength exceedence

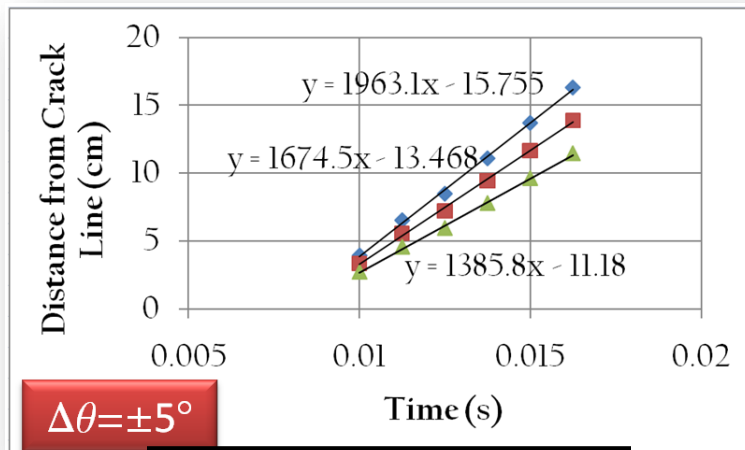
# Consequence of Rupture-Measurement of Fluid Velocity

- Fluid Velocity Measurements from high speed video
- Flow upon crack opening accelerated and then reached a reasonably constant velocity of ~17 m/s

$$V_{fluid} = 16.7 \pm 2.9 \text{ m/s}$$

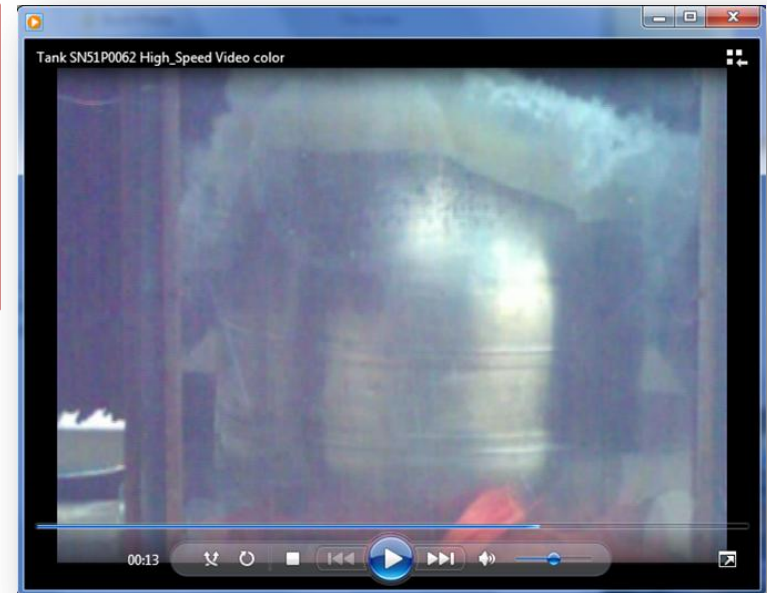
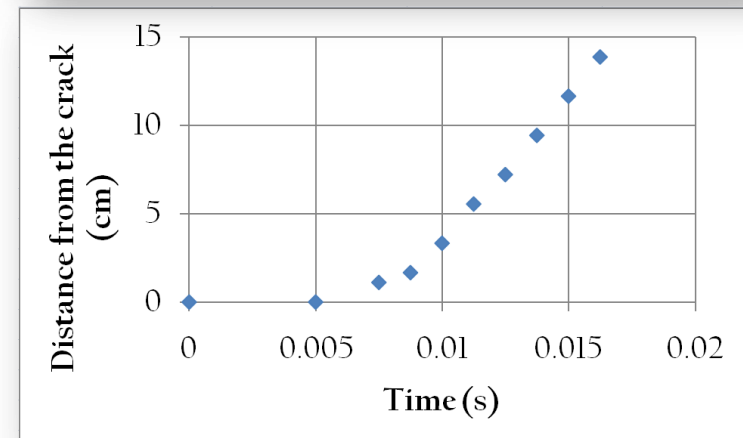
- Concerning is the *quick* dispersion of highly reactive propellant, contact with other nearby hardware and the resulting consequences of such a contact
